Laser Incident in the NASA Ames Unitary Plan Wind Tunnel

Wind Tunnel Operations Division
Ames Research Center, NASA

103rd Semi-Annual Meeting

May 2005
Buffalo, New York

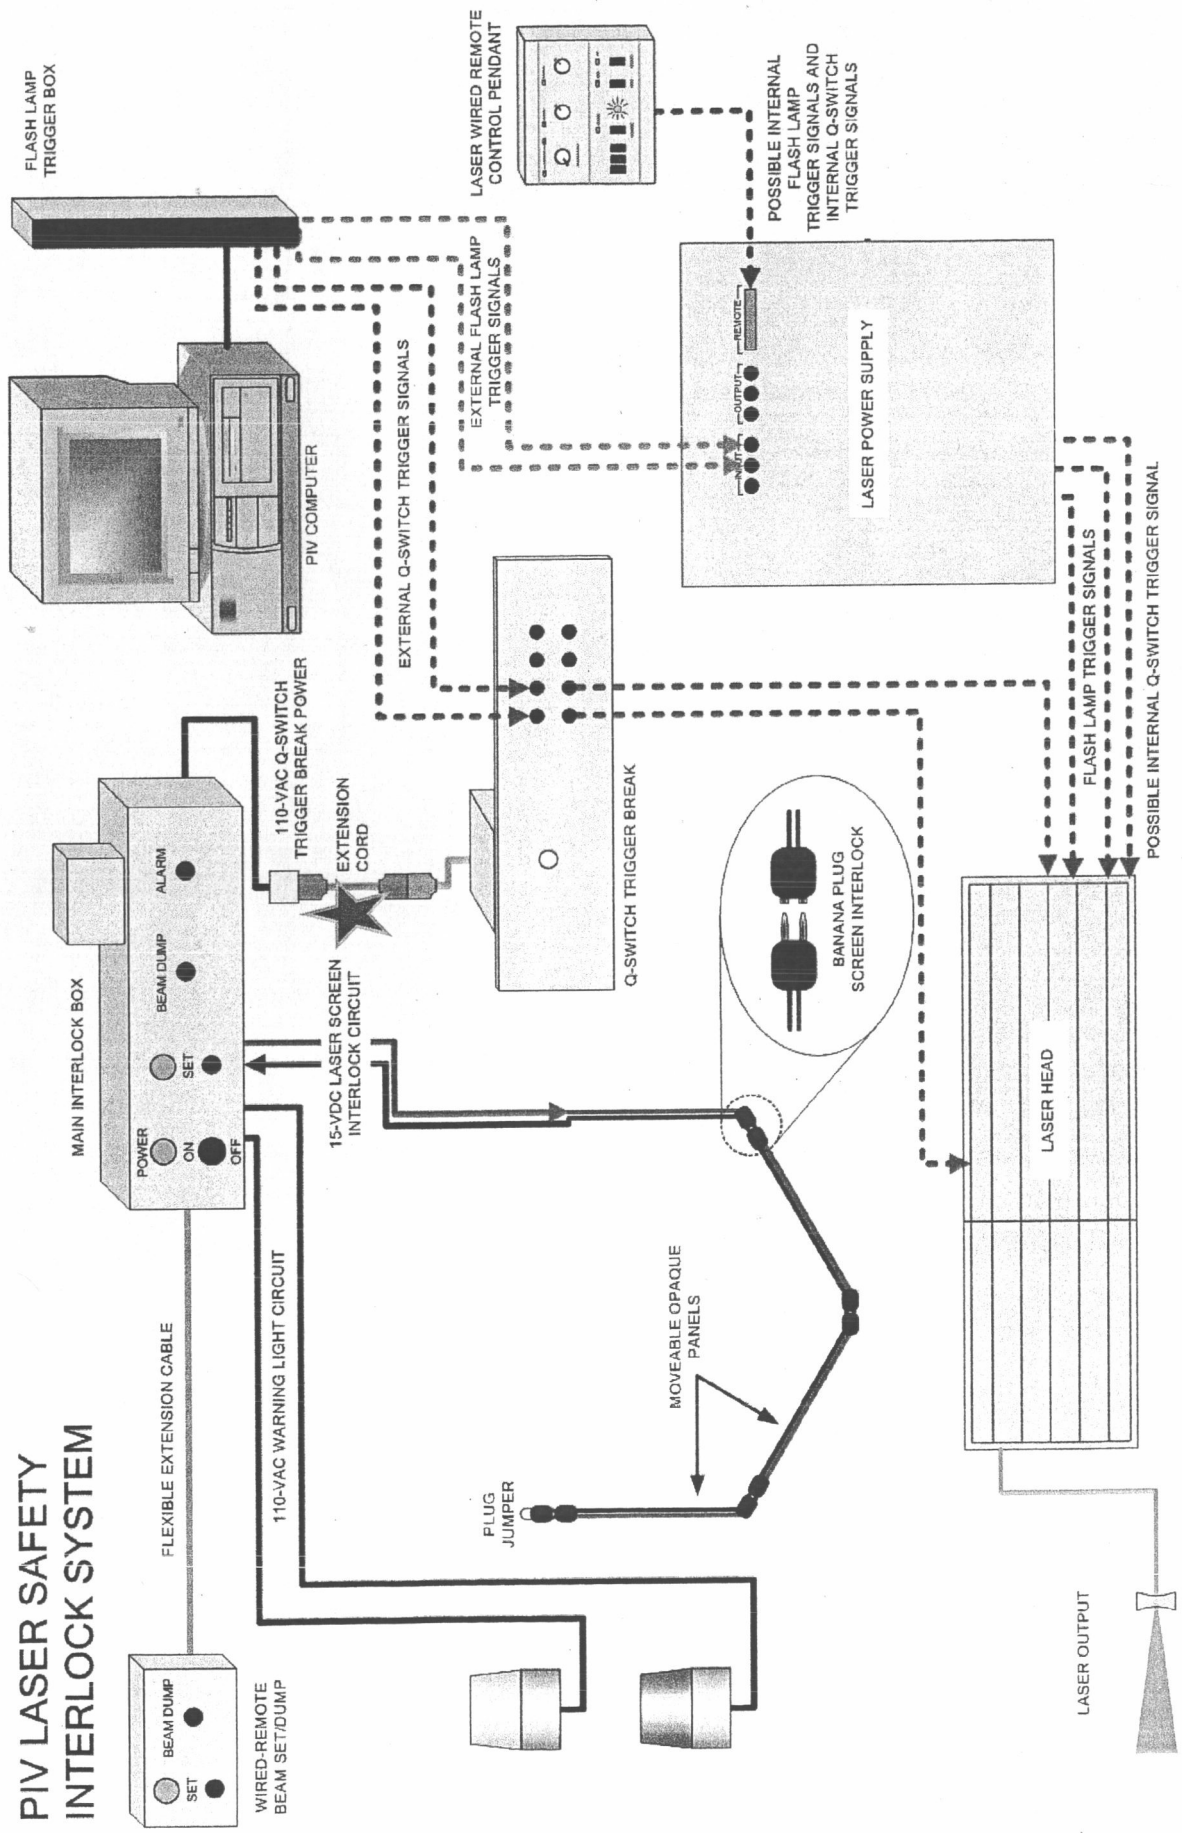
Safety Interlock Cable

PIV Laser Safety Interlock System

Correct Connection - End of extension chord plugged into the interlock box.

Incorrect Connection - End of extension chord plugged into outlet by mistake and therefore bypasses safety interlock system.

- Modified interlock system with unique electrical connectors
- Lock Out Tag Out (LOTO) required for tunnel access when PIV system installed in facility.
 - Power supply locked out
- Physical beam block at laser head and window.
- Entire test team adopt 12 hour work rule
- Redefine what a configuration change is
- Installed emergency stop switches
